# ICC-ES TEST REPORT

**NFPA 285 (Fire Propagation Characteristics of Exterior Wall Assemblies)**

**PRODUCT: AMERACORE® FR Metal  
Composite Material (MCM)  
Panels**

**Report No.:** ALAB021425-66  
**Test Date(s):** 10/23/2025  
**Report Date:** 02/18/2026  
**Pages:** 39

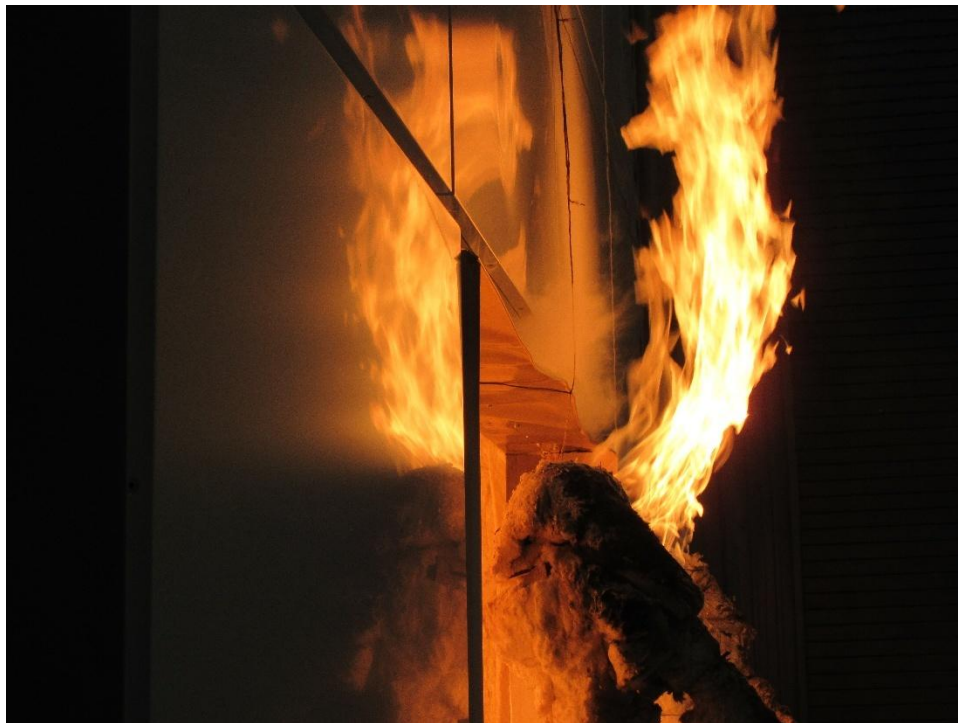
**Photo No. 8**  
**Smoke emitting from between header flashing and panel system (5:56 into test)**

| Time (min:sec) | Observation |
|---|---|
| 5:56 | Slight smoke emitting from between top of window header flashing/panel system |

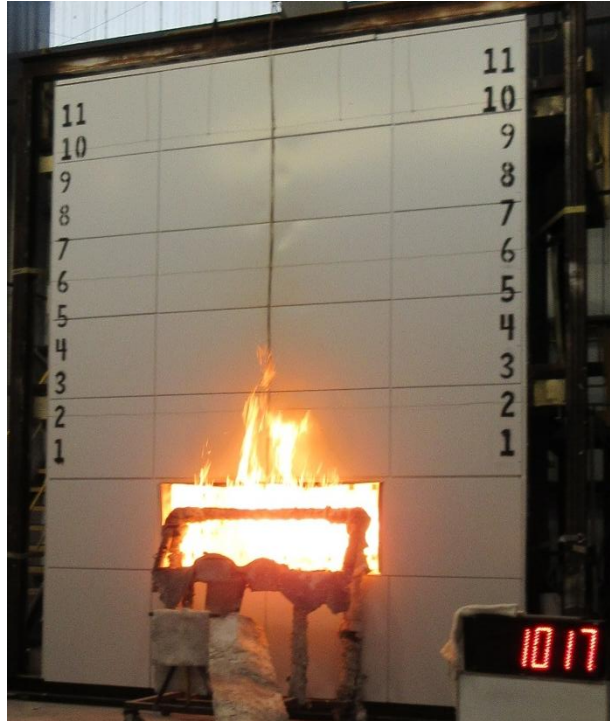
**Photo No. 9**  
**Discoloration along vertical centerline and warping of panels**

| Time (min:sec) | Observation |
|---|---|
| 10:25 | Slight warping of panels along vertical centerline of assembly above window opening |

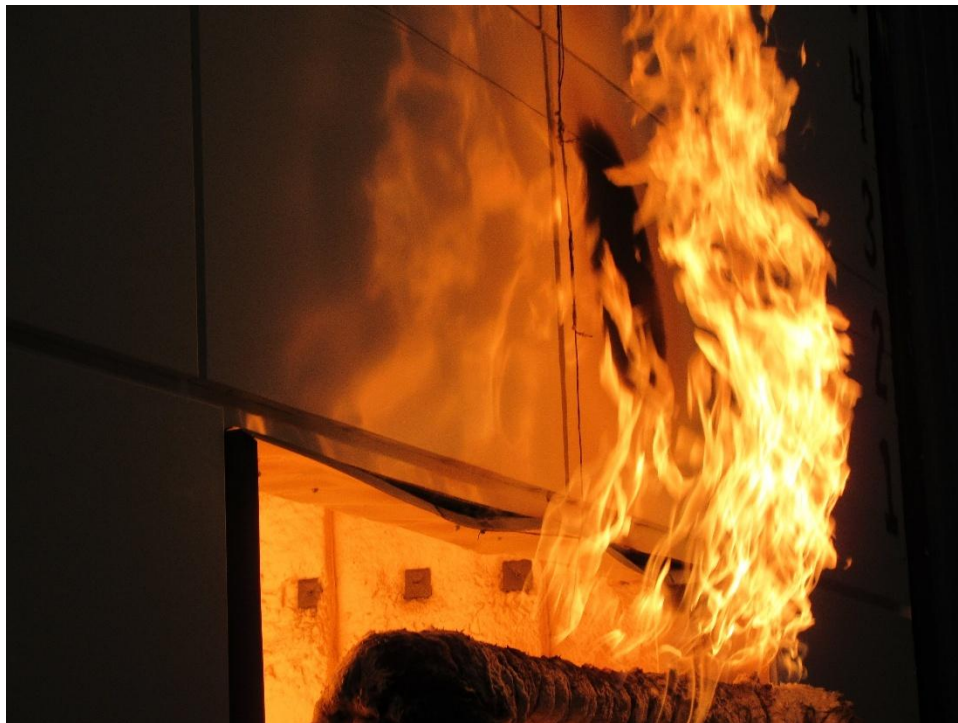
**Photo No. 10**  
**Discoloration of panels directly above window header – (11:46)**

| Time (min:sec) | Observation |
|---|---|
| 11:46 | Slight discoloration on panels above window opening; window opening jamb flashing discolored |

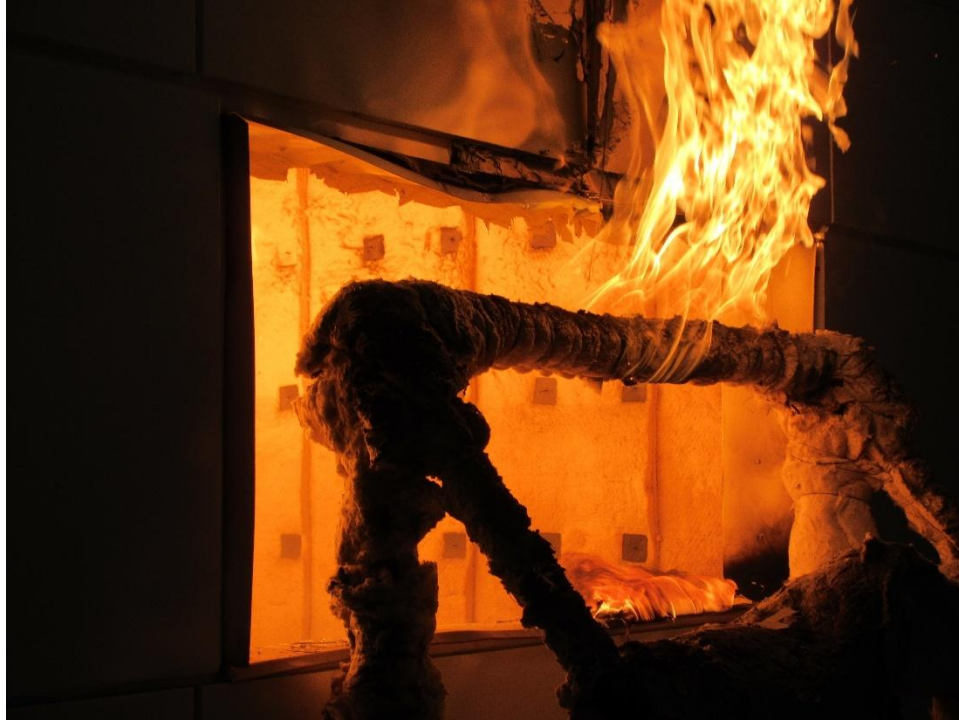
**Photo No. 11**

| Time (min:sec) | Observation |
|---|---|
| 19:11 | Window header flashing beginning to melt. Increased warping of panels |

**Window header flashing and first course of panels beginning to melt above window header – (18:00)**

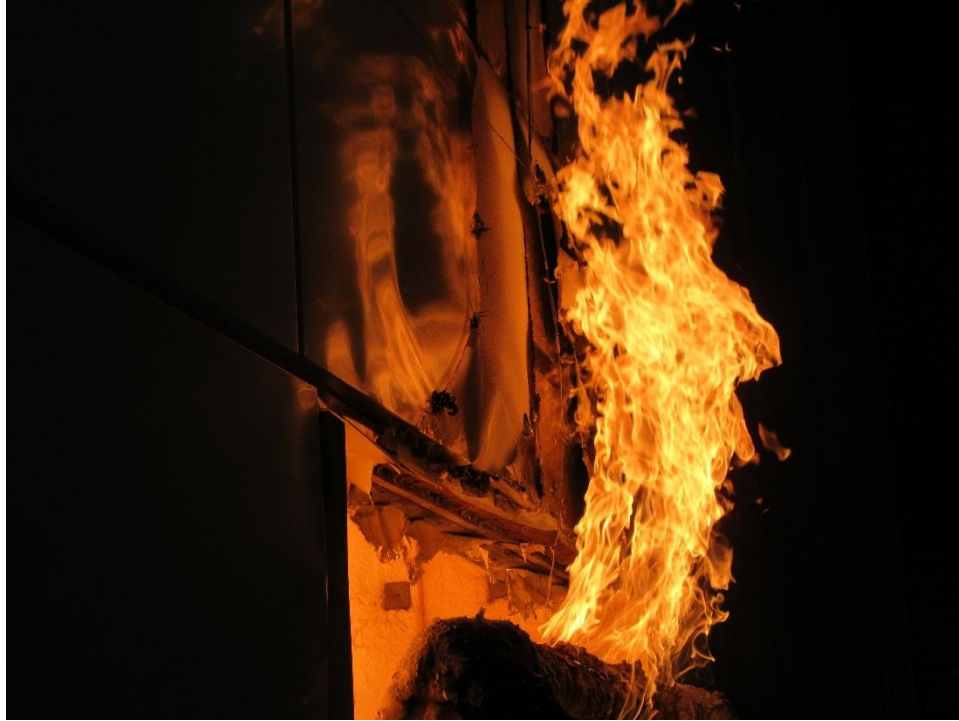
**Photo No. 13**

| Time (min:sec) | Observation |
|---|---|
| 23:27 | First course of Panels directly above window header beginning to melt at center of wall assembly. Increased |

**Window header flashing fully melted and significant melt of MCM panels above window header – (24:00)**
